Manhole Inspection Summary

Manhole # S35II_043MH

Insp Date: **3/13/07 10:19 AM**

Location Address: **1720 GUILFORD AVE**

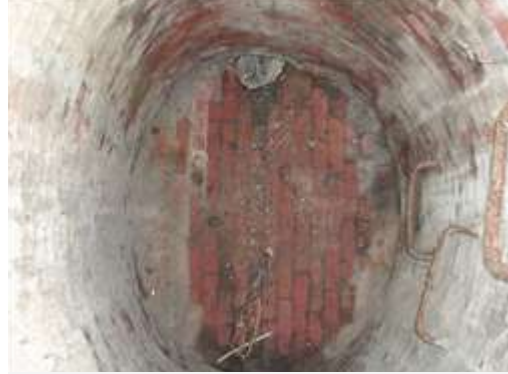
Top View

Channel Material: **Brick** ☐ Parged ☒ **Debris** (not Condition related)

Steps Count: **4** Missing: **0** ☒ **Corroded**

Corroded steps. Channel debris.

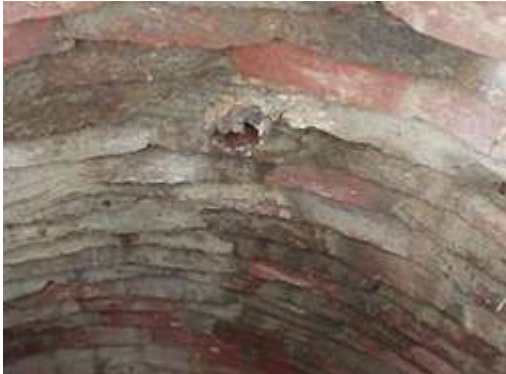
Defect

Infiltration: ☐ None ☒ **Joint** ☐ Cracks ☒ **Mortar** ☐ Roots ☐ Wall

Infiltration: ☐ None ☐ Joint ☐ Cracks ☐ Mortar ☐ Roots ☒ **Wall**

Adjustment, Corbel and Barrel infiltration. Valve.

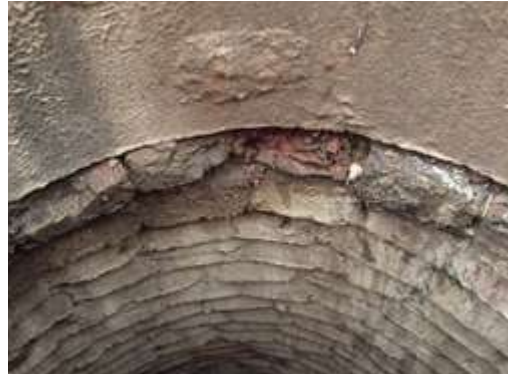
Defect

Frame Offset: **0** (in.) Condition: ☐ Sound ☐ Cracked ☒ **Leaks**

Condition: ☐ Sound ☐ Cracked ☐ Root Intrusion ☐ Loose Brick ☒ **Deteriorated**

Frame leaks. Adjustment deterioration and infiltration. Barrel infiltration - other side.

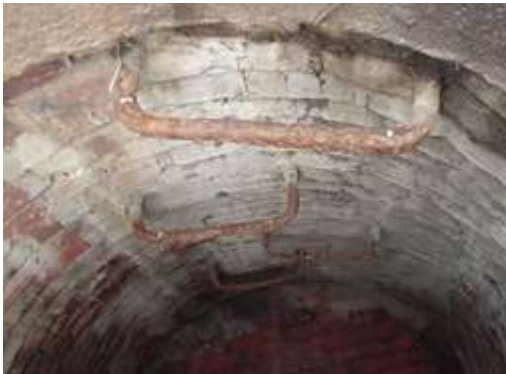
Defect

Frame leaks. Adjustment deterioration and infiltration. Barrel infiltration.

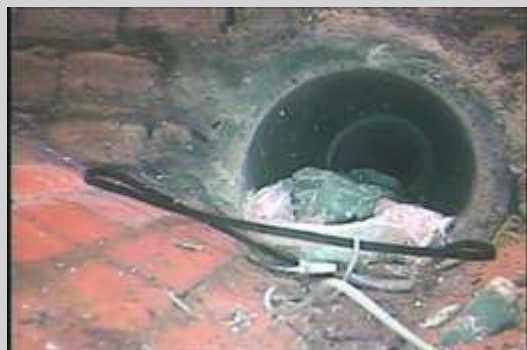
8 in. Circular Gravity Sewer

Pipe Out @ 12 O'Clock

Deposits: ☐ None ☐ Mud ☐ Sludge ☒ **Debris** ☐ Grease

Deposits Extent: **Light**
